FINAL REPORT

Somersworth Library

Feasibility Study for Accessibility

Placework

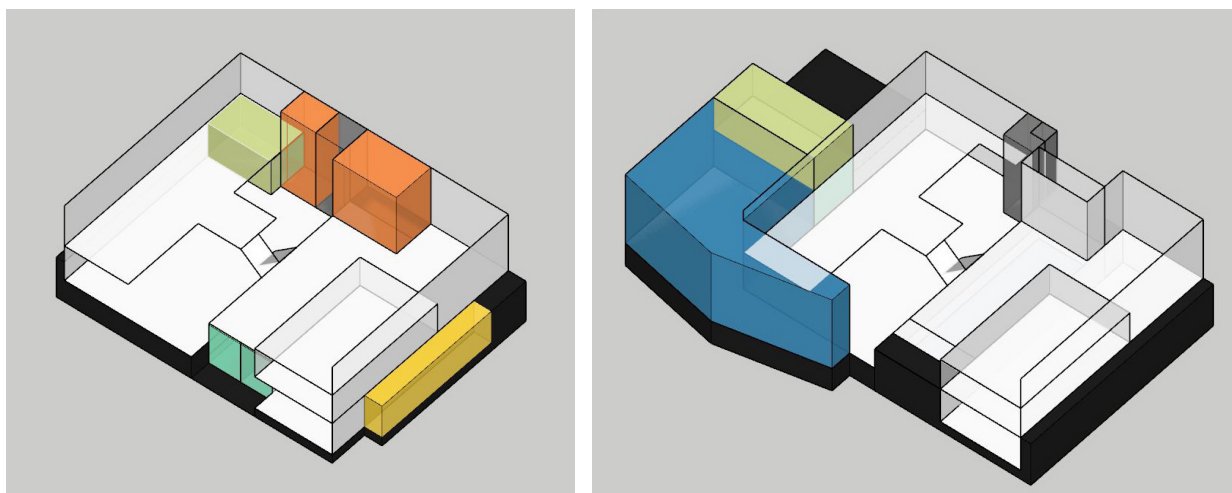
Progress Models for Scheme 1 and Scheme 2
presented to the Somersworth City Staff on August
6th, 2021.

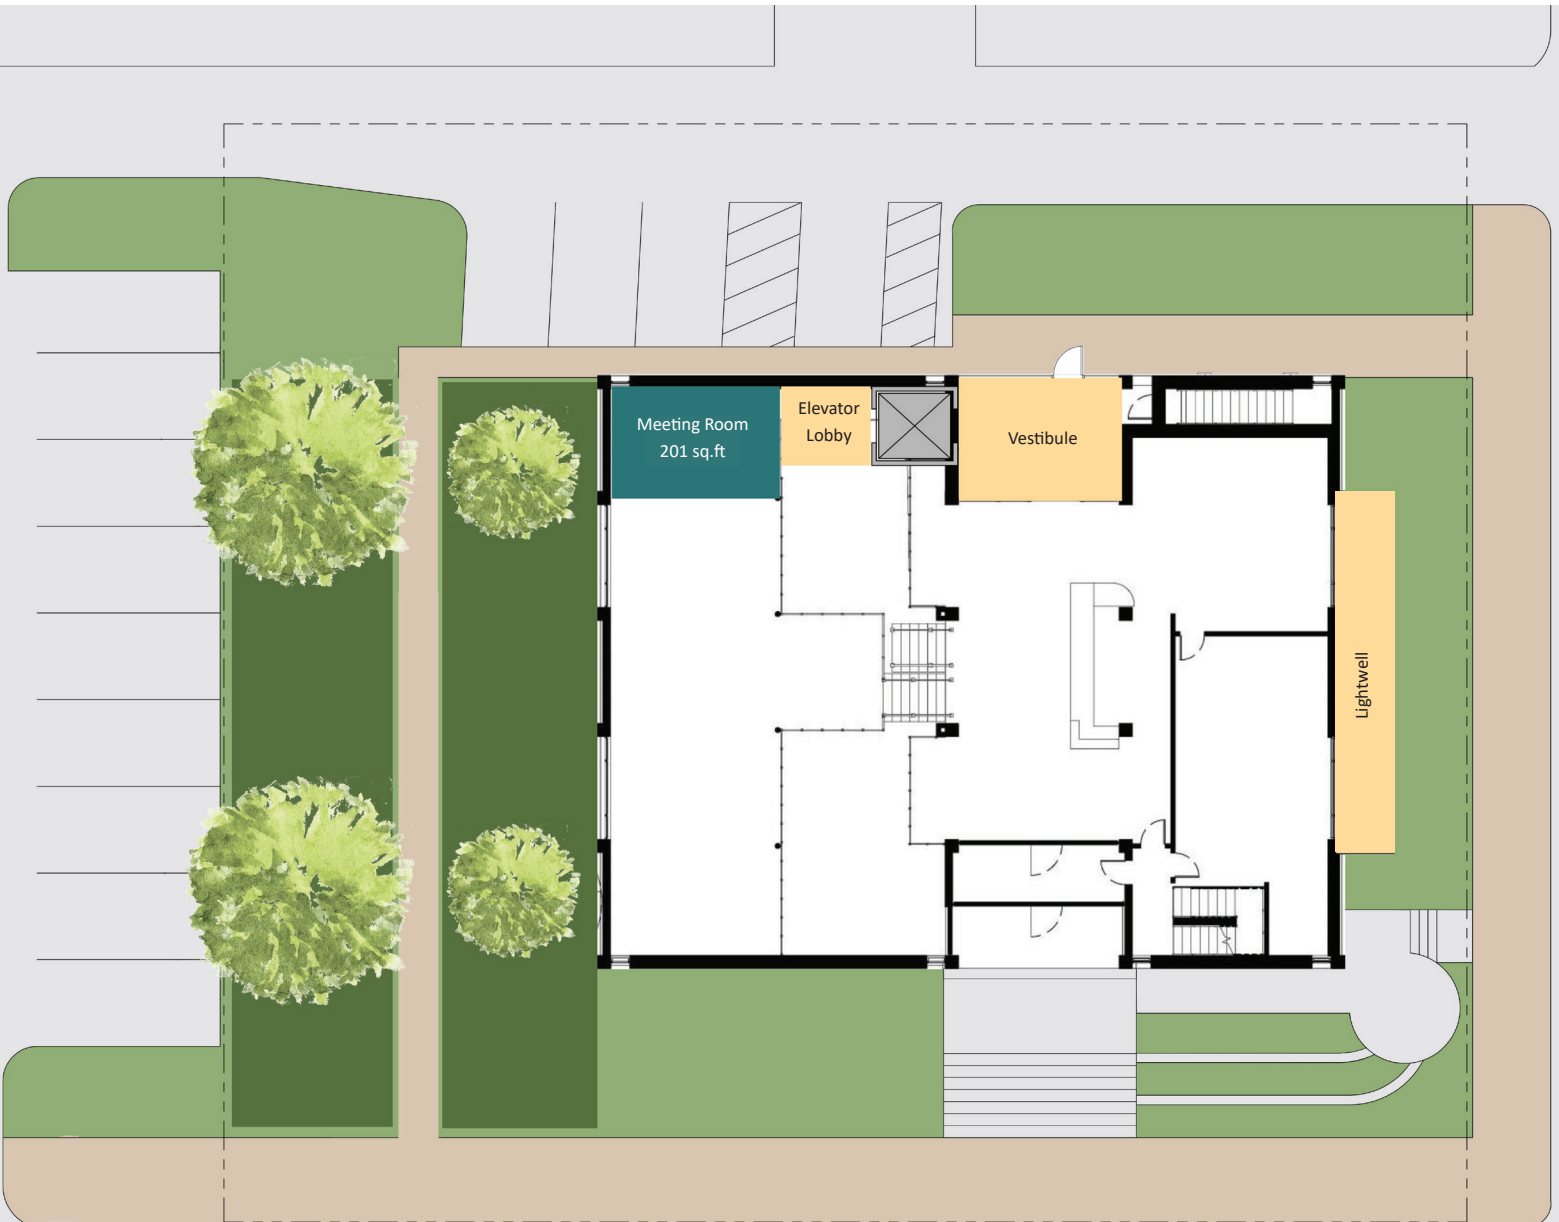
FIRST FLOOR PLAN + SITE PLAN
NOT TO SCALE

SCHEME 1: RENOVATION ONLY

This conceptual design plan illustrates an efficient renovation of the existing spaces in the library. The private meeting room/study space is located within the lower level reading area so that it minimizes the impact on the open feel of the library space. The vestibule at the back is widened in order to make it an accessible entrance (See Addenda for Code & Life Safety Analysis). Should the decision be made to not add a sprinkler system to the building, an enclosed elevator lobby is required for fire separation at each floor level.

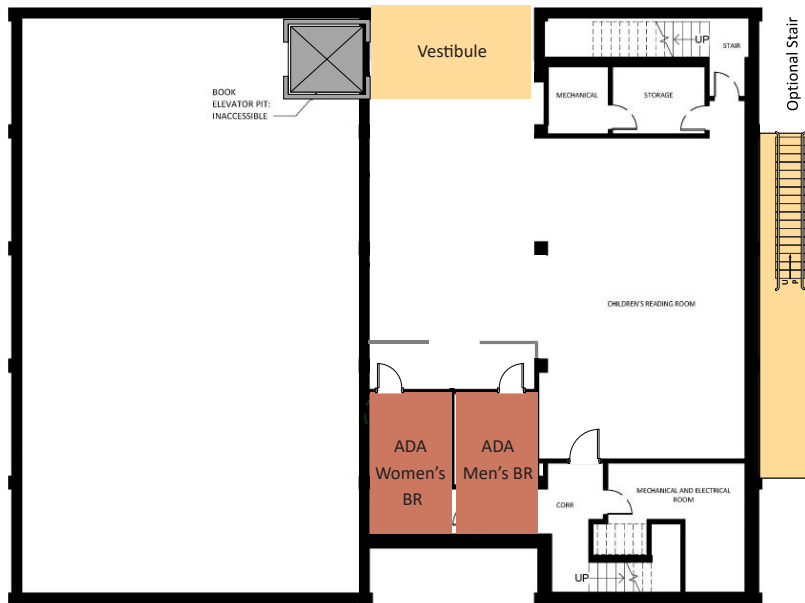
BASEMENT PLAN
NOT TO SCALE

In the basement, the space is reconfigured (at the expense of storage space) and opened up to better accommodate shelving and seating. An expanded light well along the North wall will provide more natural light. The bathrooms are reconfigured, taking up some previous storage/office space, so that their entrance is toward the elevator to assist with accessibility and wayfinding.

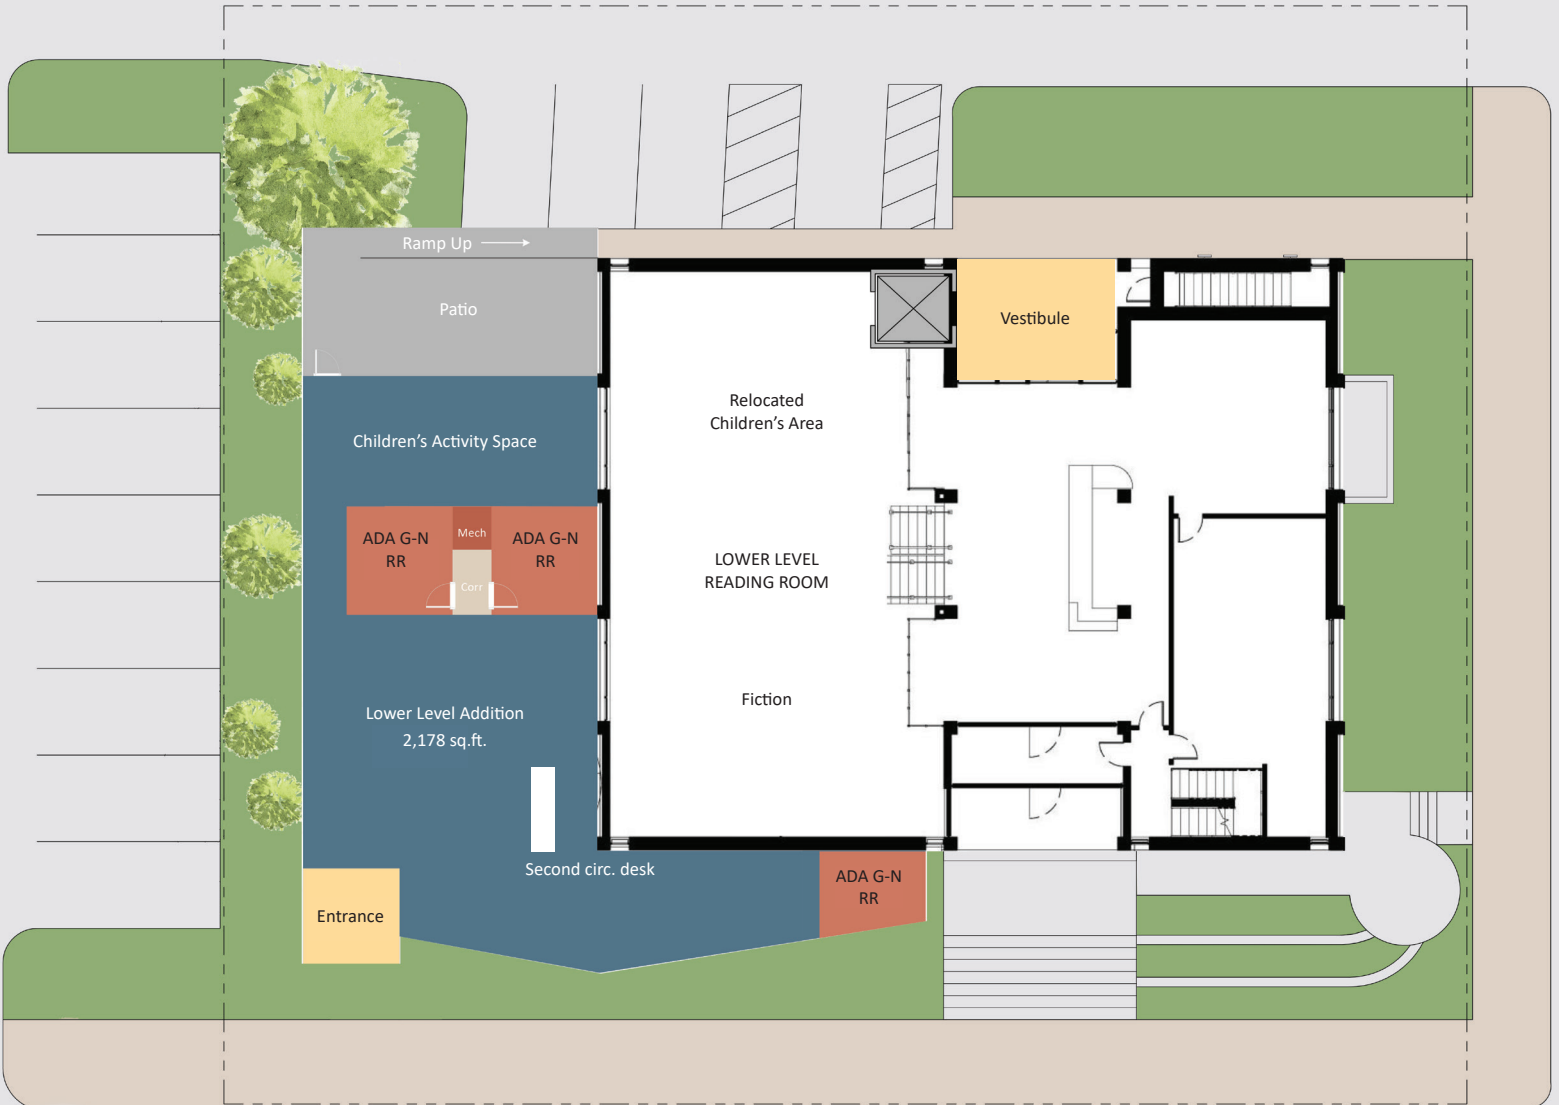
FIRST FLOOR PLAN + SITE PLAN
NOT TO SCALE

SCHEME 2: RENOVATION AND ADDITION

In Scheme 2, an addition to the library promotes accessibility, maintains the historical character of the original structure, and enhances library patrons' experience. The shape of the addition in plan is meant to represent the organization of program spaces, and is not yet intended to represent literal architecture. All requested functions (quiet study space, accessible restrooms, improved children's area) are located in the addition, as mentioned in the Design Narrative. Square footage is to be added to the lower level reading room and upper reading gallery to expand existing stack space on those levels.
